All Bay Home Inspection, Inc.

Inspection Site: [Sample, CA 94019](#) • Report # I0816412

Subject: [Building Maintenance Inspection](#)

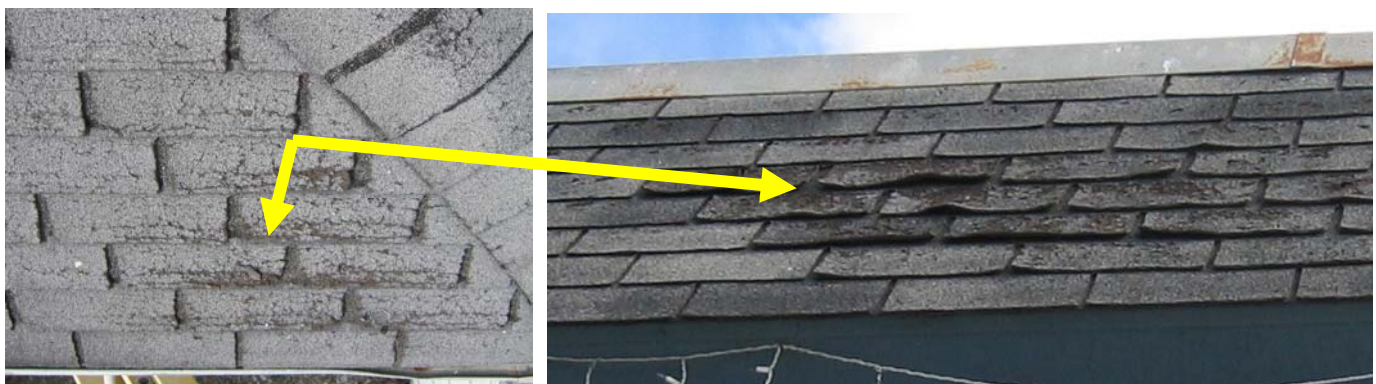
1. Voids in the gravel were observed on the built-up roofing. This usually leads to a shortened life expectancy and increases the potential for ultraviolet damage to the roofing. Missing gravel should be replaced.
2. The composition roofing used on the mansard areas of the building is near the end of its useful life. Expect to replace the roof soon.

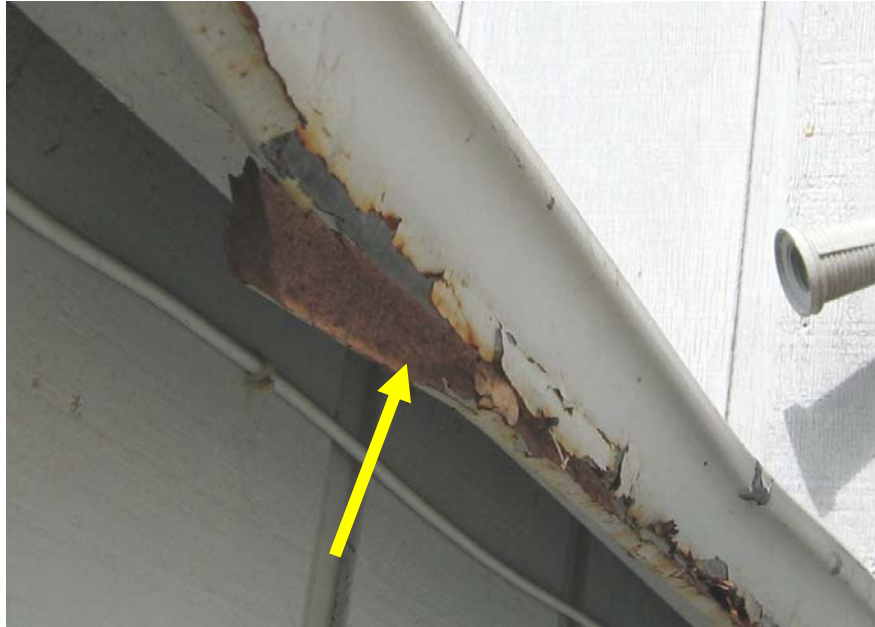
3. The gutters are rusted through in various locations. Replacement is recommended.

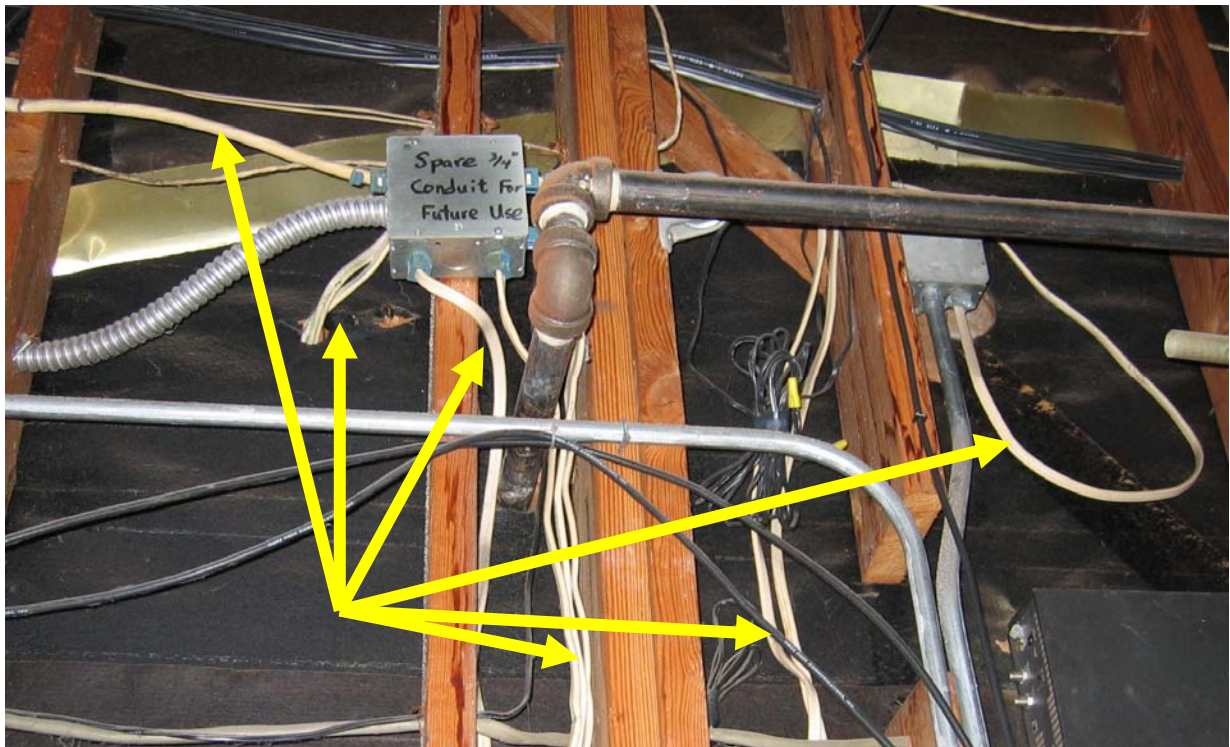
4. The inspection of the electrical system revealed some non-standard and/or amateur wiring practices. Romex wiring is not approved for use in commercial structures (white wiring).

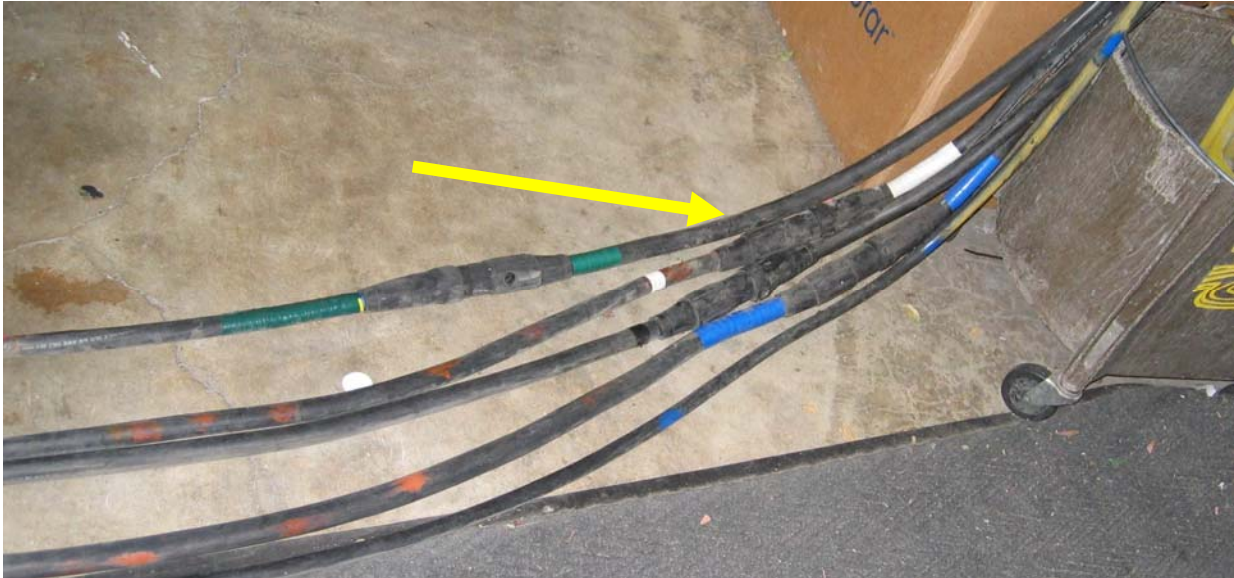
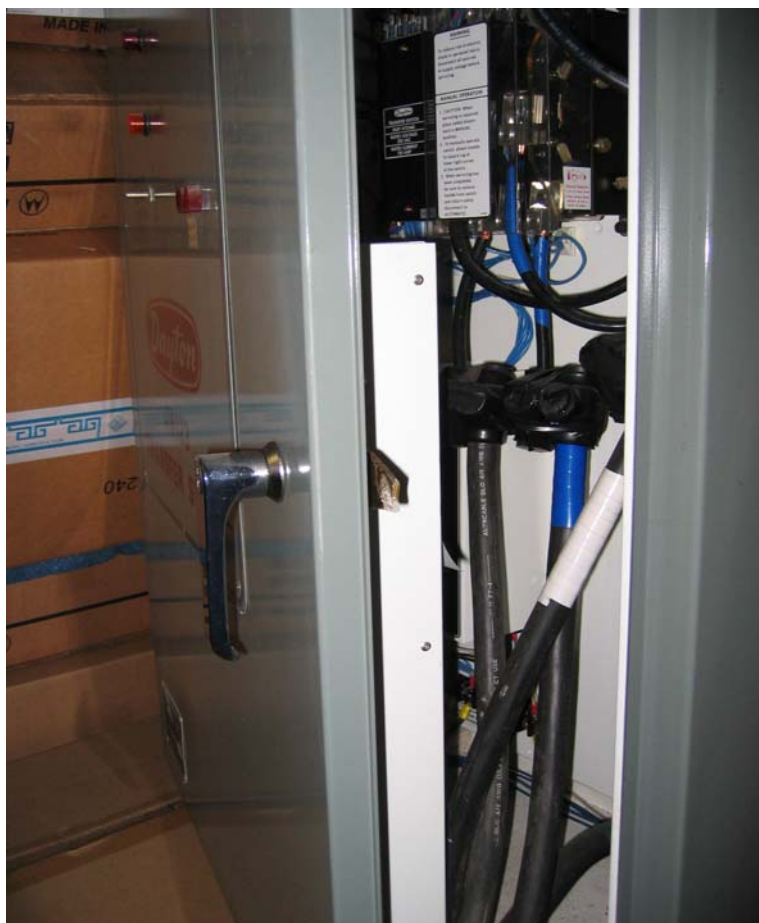
5. The electrical system has a standby generator. The electrical panel is wired in an open position. The wiring that enters the building should be placed in a protective conduit.

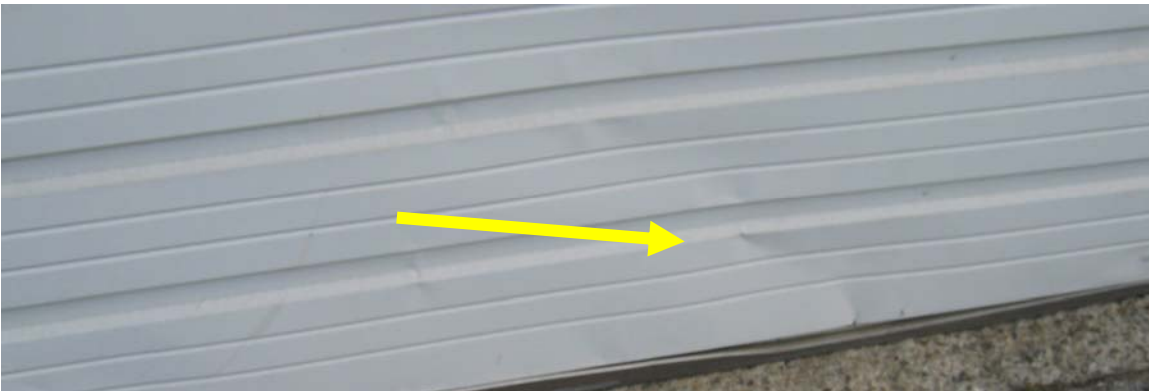
7. The exterior doors have large gaps at the bottom. The installation of a threshold is recommended. The sealing of the gap at the bottom of the door will help prevent vermin intrusion into the structure.
8. The bottom panel of the metal overhead garage door is damaged. Replacement is recommended.

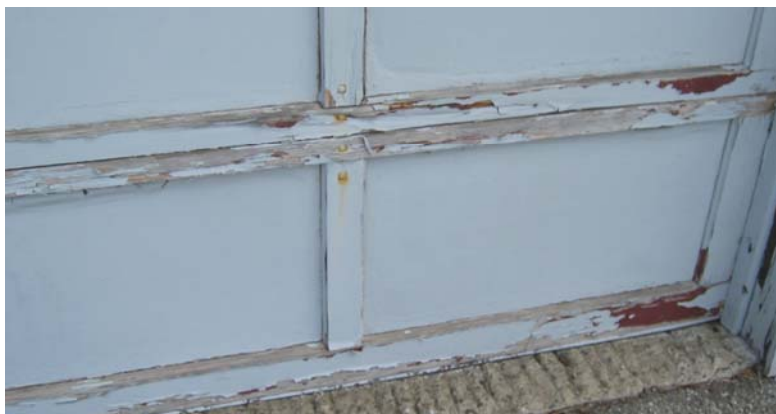
9. The wood sectional garage door is in poor condition. Replacement is recommended.

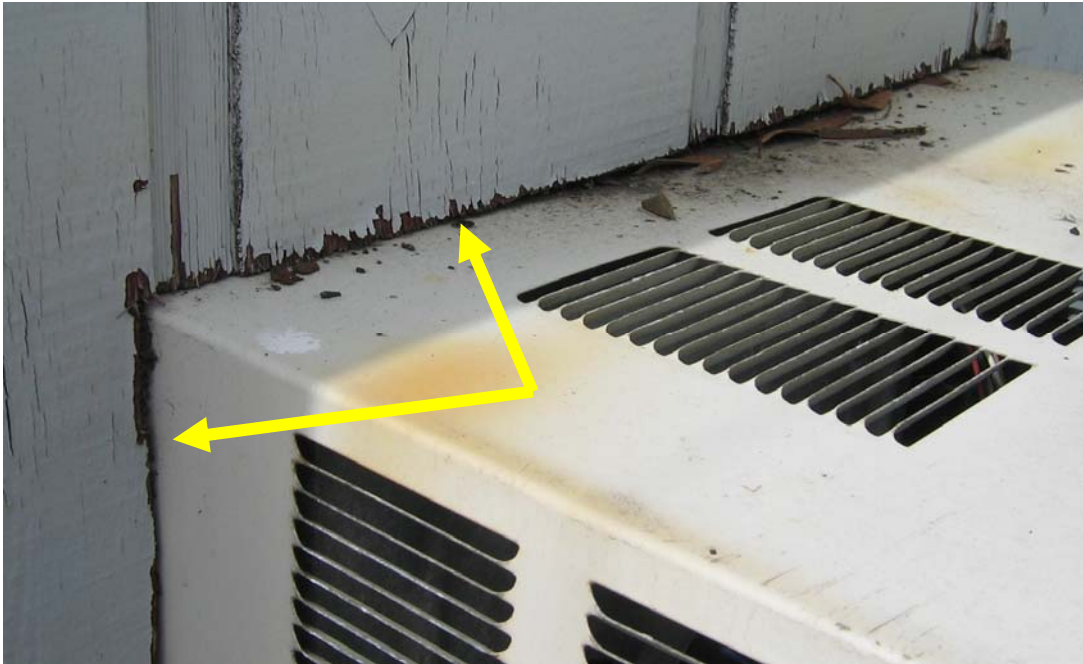
10. The wall AC unit is not properly flashed where it passes through the wall framing.

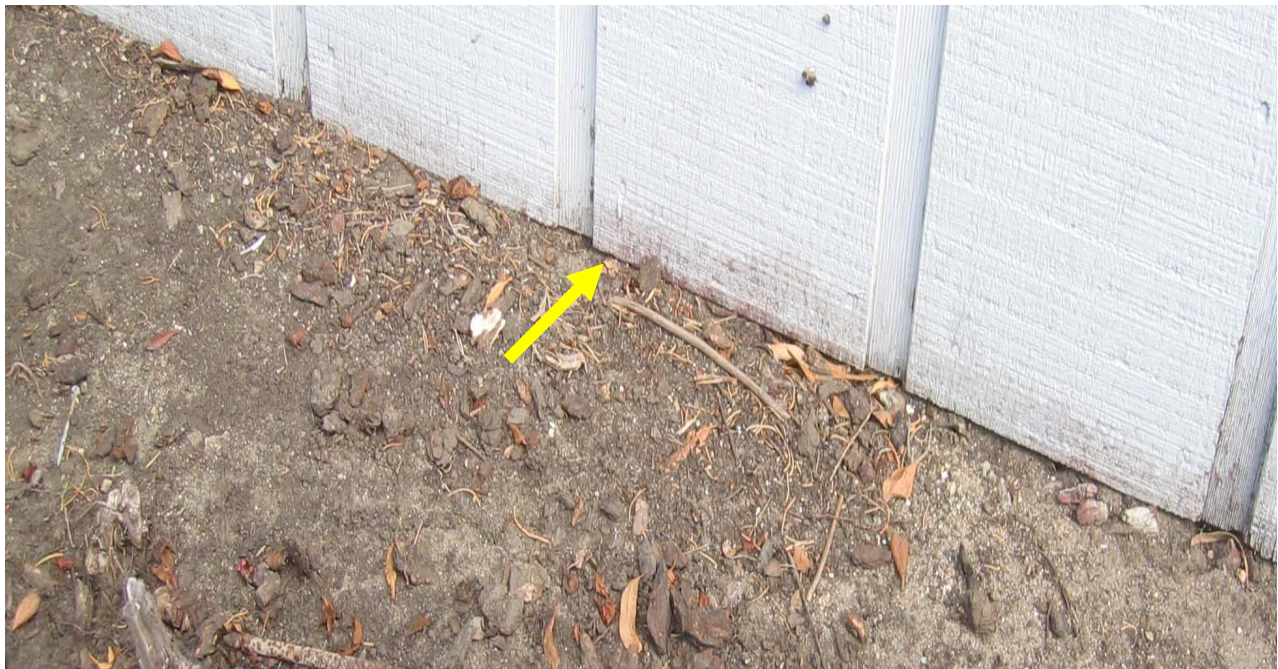
11. The plywood siding is in contact with the concrete. This type of installation is prone to rot and/or insect activity. All concrete to plywood contact should be eliminated.

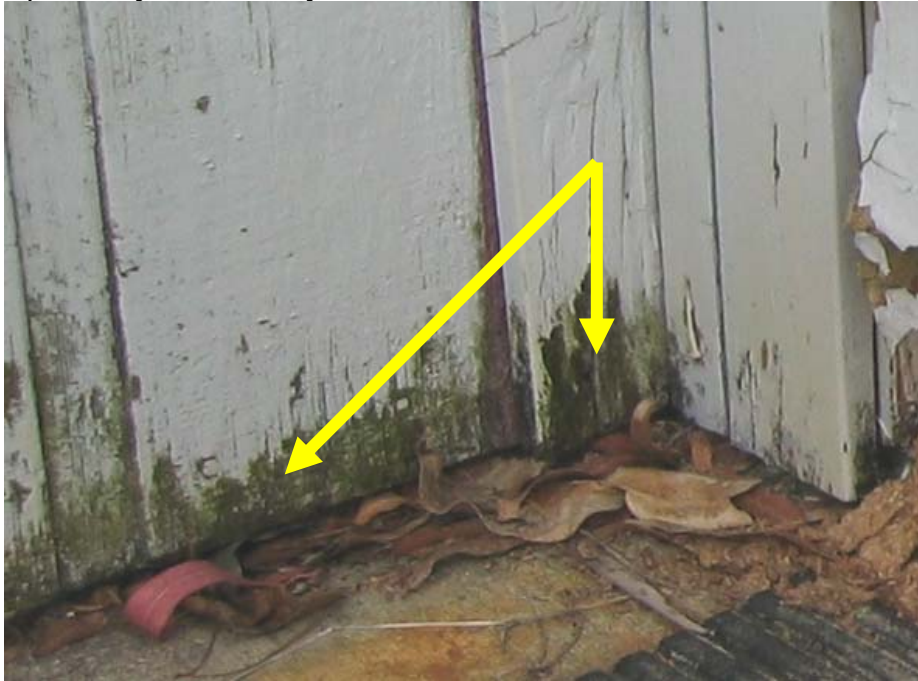
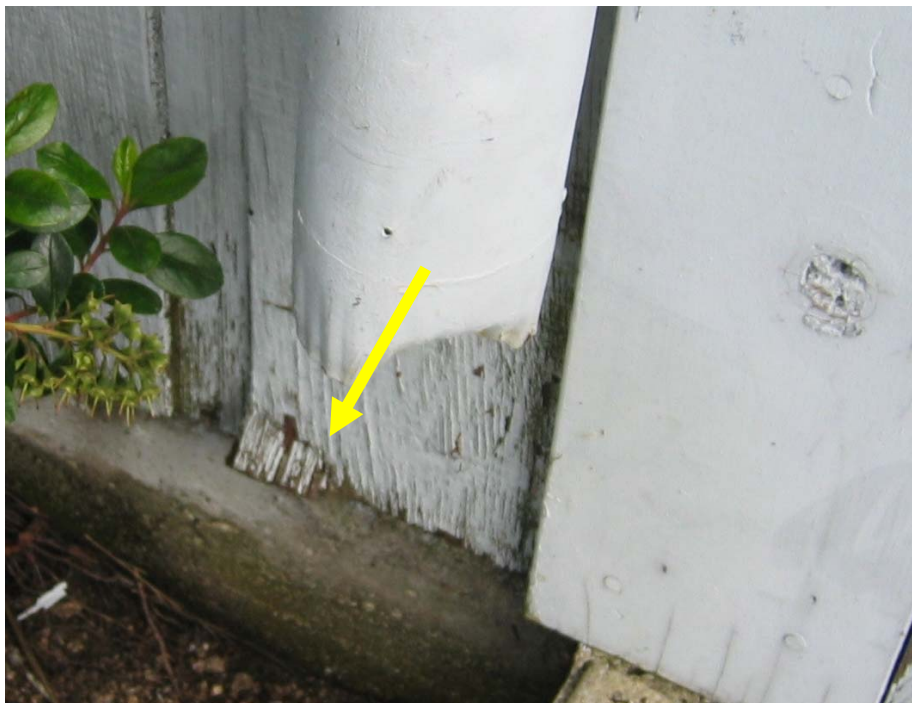
12. The plywood siding is aging noticeably and should, eventually, be replaced. In the interim, localized repairs may be necessary.

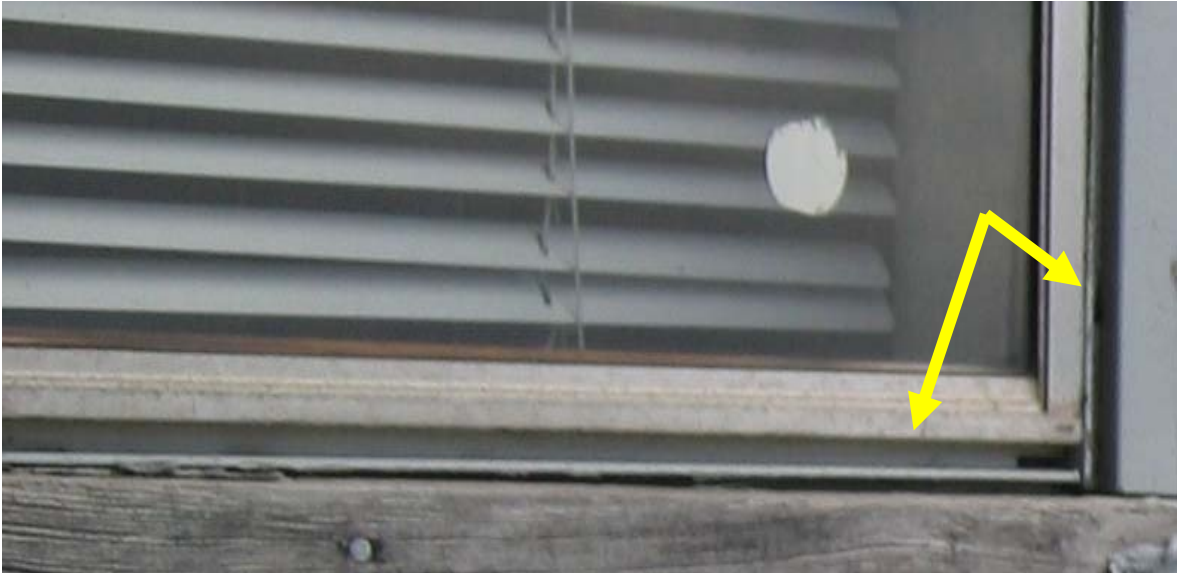
14. The windows require caulking at the exterior. Water leaking through unsealed areas can cause structural damage. The unsealed areas can also allow air intrusion into the structure.

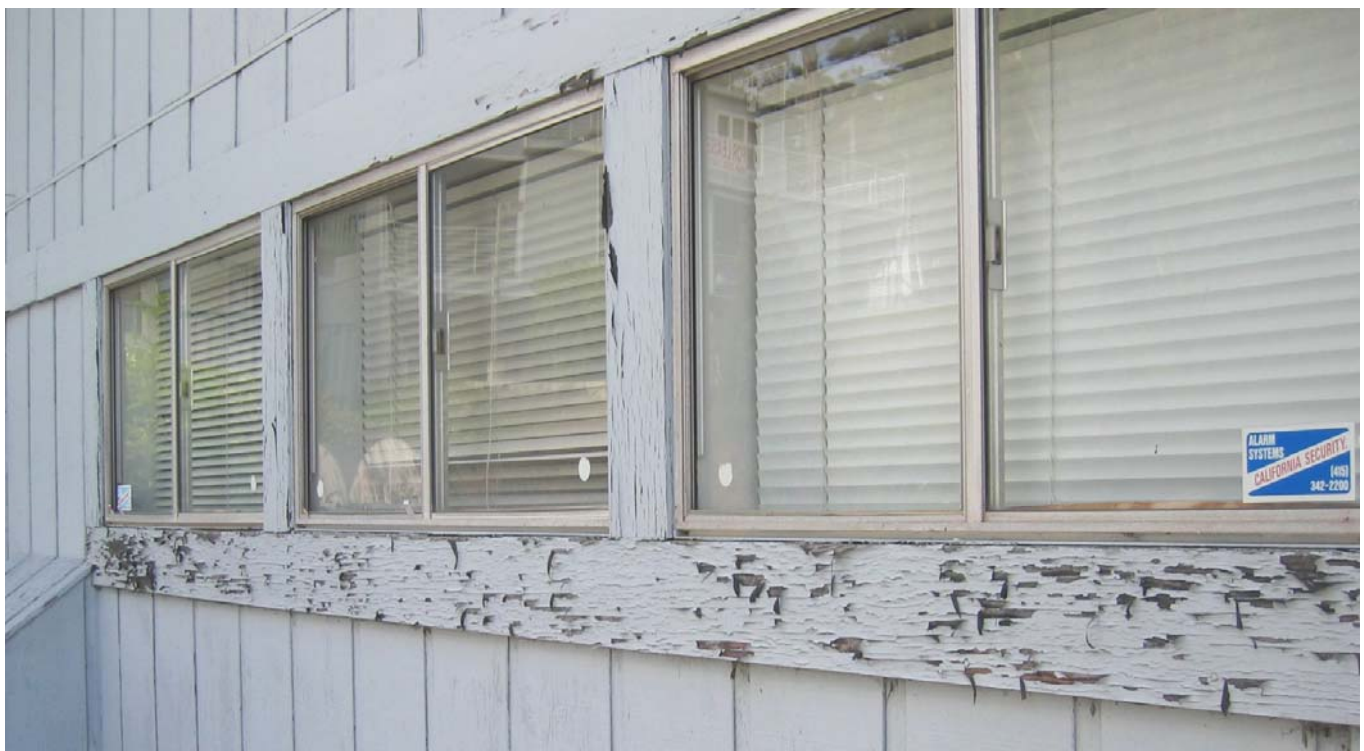
15. To help preserve the structure the wood exterior components should be painted.
