# All Bay Home Inspection, Inc.

**Inspection Address:** Gilroy, Ca 95020

**Subject:** Property Inspection, New Construction

Upon inspection of the new home on November 19, 2004 the following defects were noted:

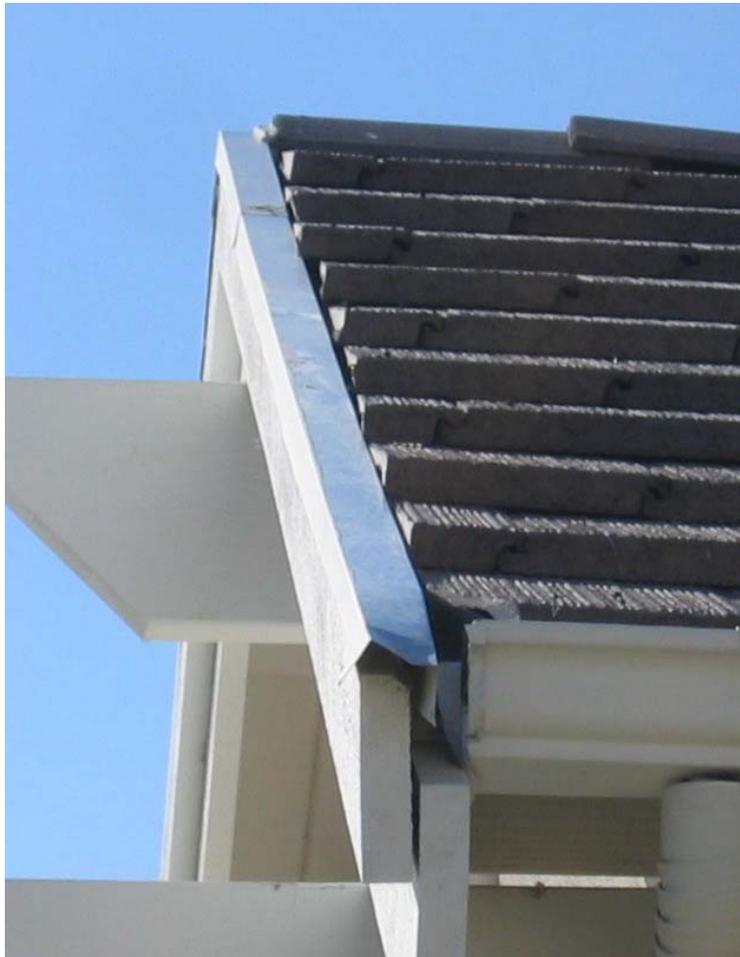
1. The installation of the concrete tile roof is incomplete. No end caps have been installed at the rake edges.

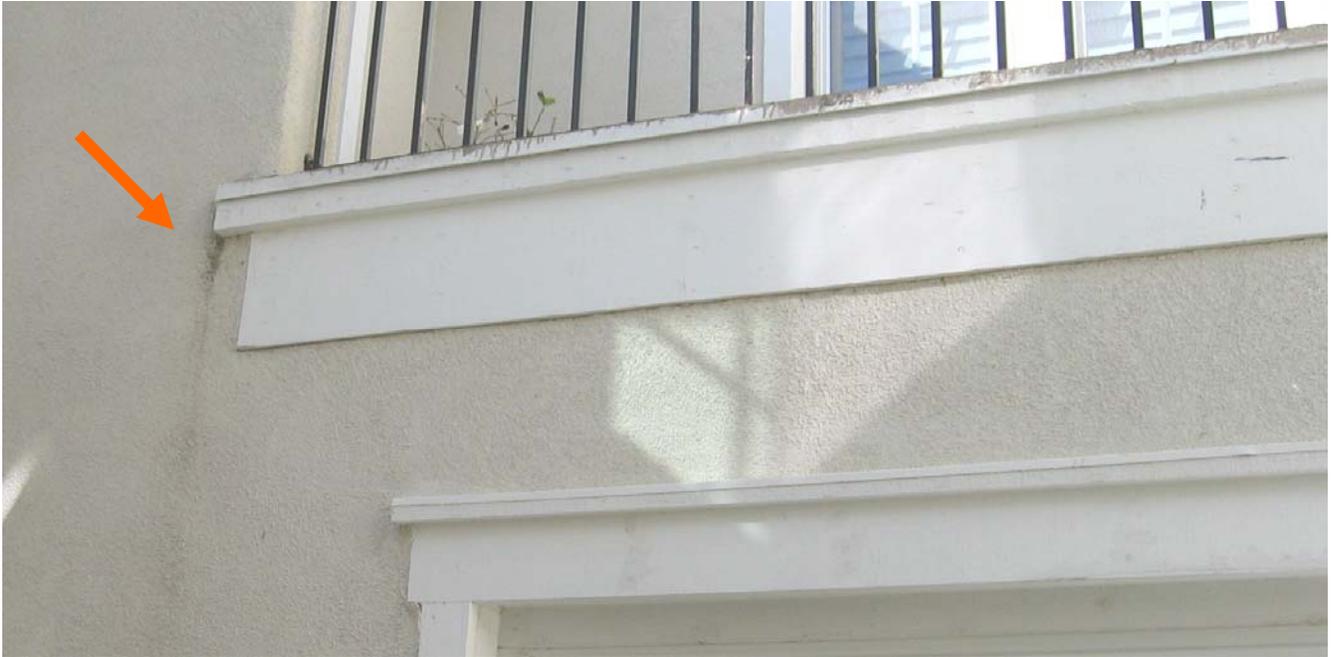
2. The number of downspouts is insufficient at the courtyard. Downspouts are generally required every 25-30 feet of gutter run.
3. No provision has been provided for balcony drainage at the courtyard.

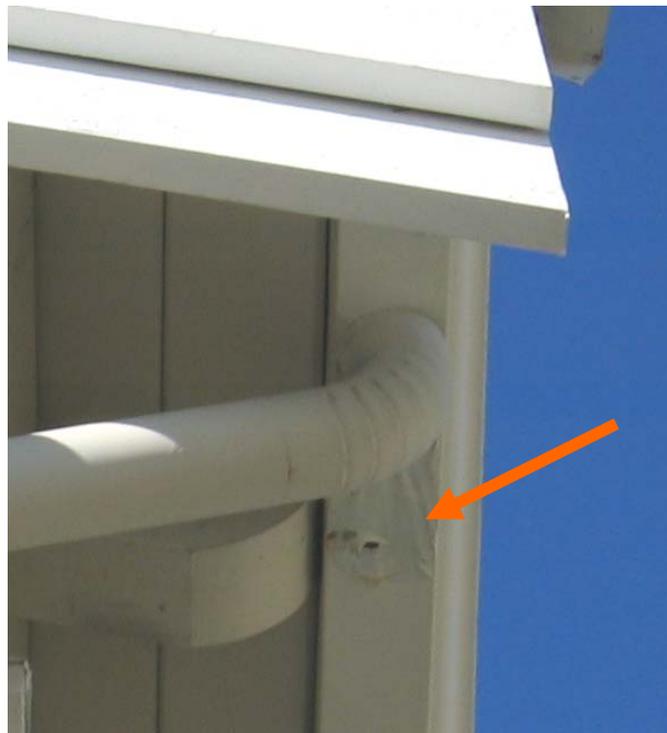
4. The gutter system is leaking and the paint is peeling at the right side front 2<sup>nd</sup> floor gutter location.

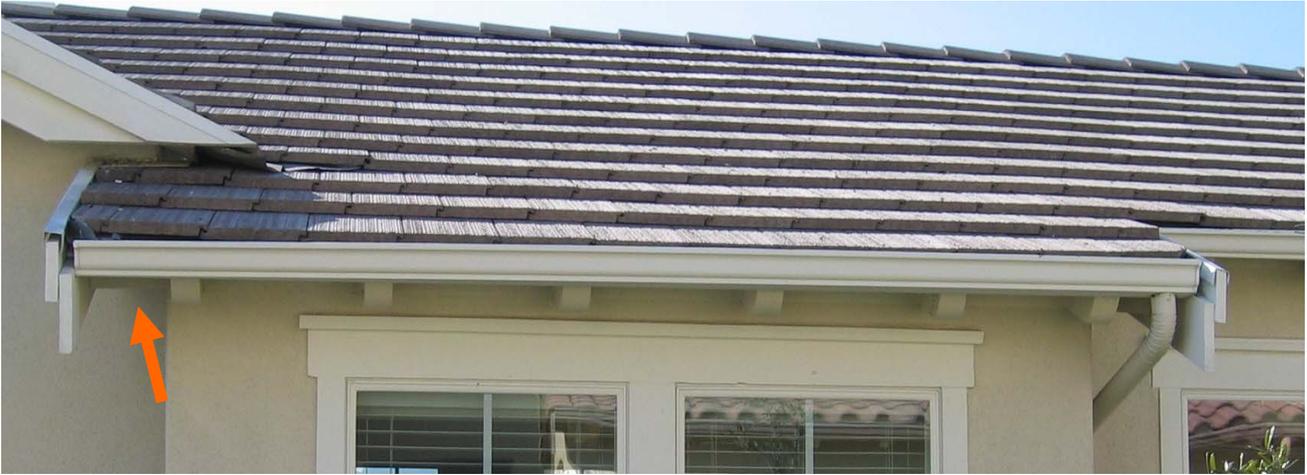
5. The section of gutter serving the right side 2<sup>nd</sup> floor bump out is improperly pitched. The low side is to the left.

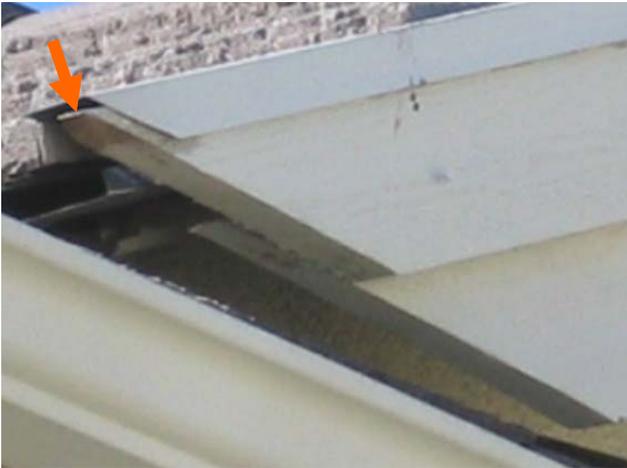
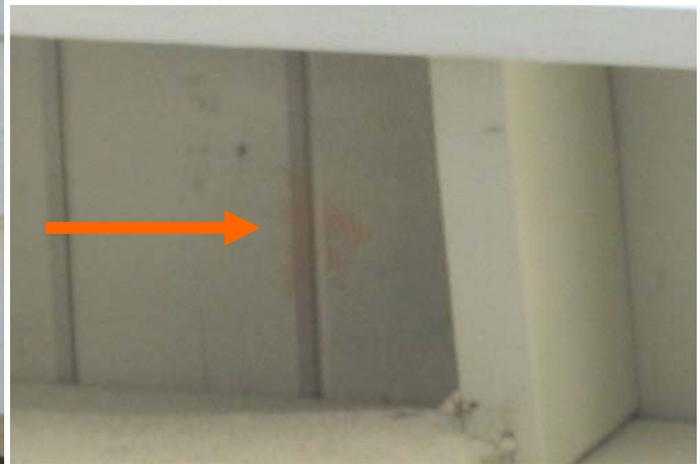
8. All of the exterior wood should be painted. The voids in the painting at the right side soffit, ends of the wood window and door trim should be properly sealed.

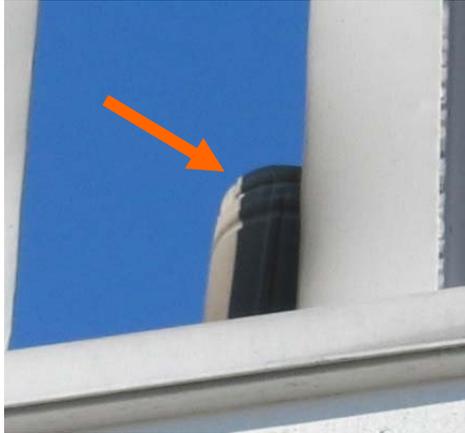
10. A rain cap should be installed on the flue vent pipe at the rear chimney location.

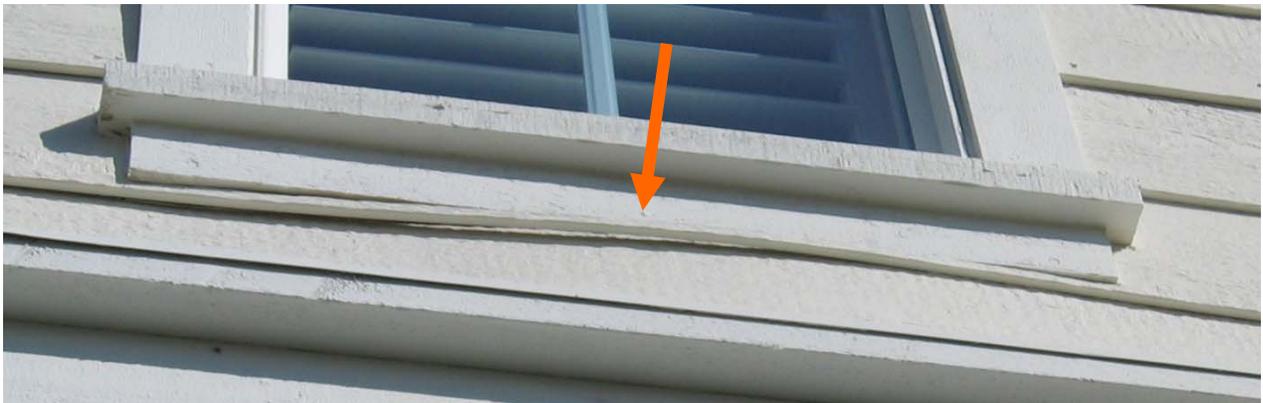
11. Minor stucco cracking was visible in various locations. This cracking does not appear to be the result of a structural failure. It is recommended that all cracking be repaired before painting.
12. The wood trim window and door trim at the stucco locations should be properly caulked. Water leaking through unsealed areas can cause structural damage.
13. The loose siding under the 2<sup>nd</sup> floor left side widow above the carport should be properly installed.

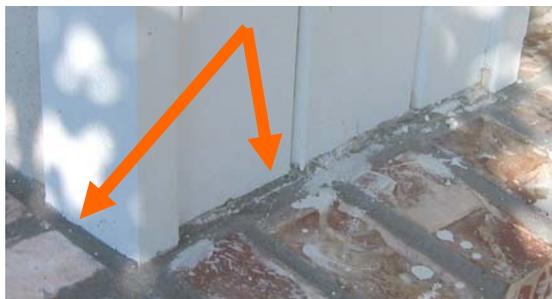
14. The wood siding at the carport column locations is embedded behind the masonry. This type of installation is prone to rot and/or wood boring insect activity. Recommendation: All wood to masonry contact should be eliminated.

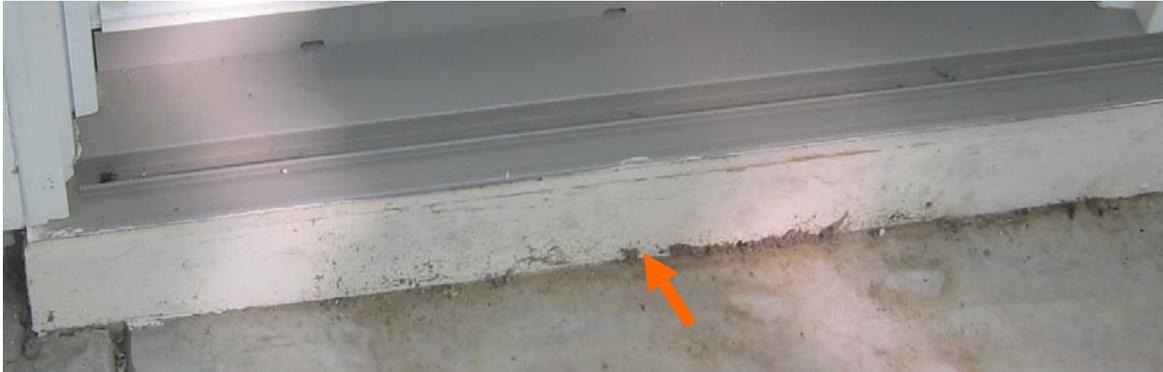
16. The wood under the threshold at one of the hallway French doors is in contact with the concrete. This type of installation is prone to rot and/or insect activity. All masonry to wood contact should be eliminated.

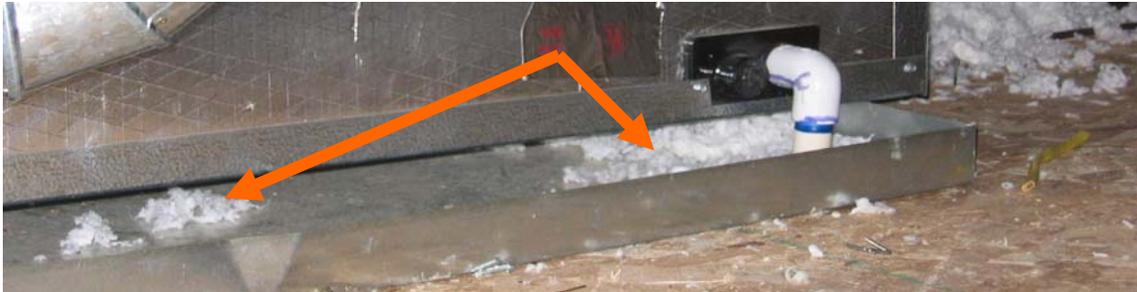
24. To reduce the potential for water damage to the ceilings/structure in the event of a leak, the attic furnaces are equipped with auxiliary drain pans below the attic furnaces. These pans have blown fiberglass insulation in the pans. The insulation will block the water flow. Recommendation: Remove the insulation.

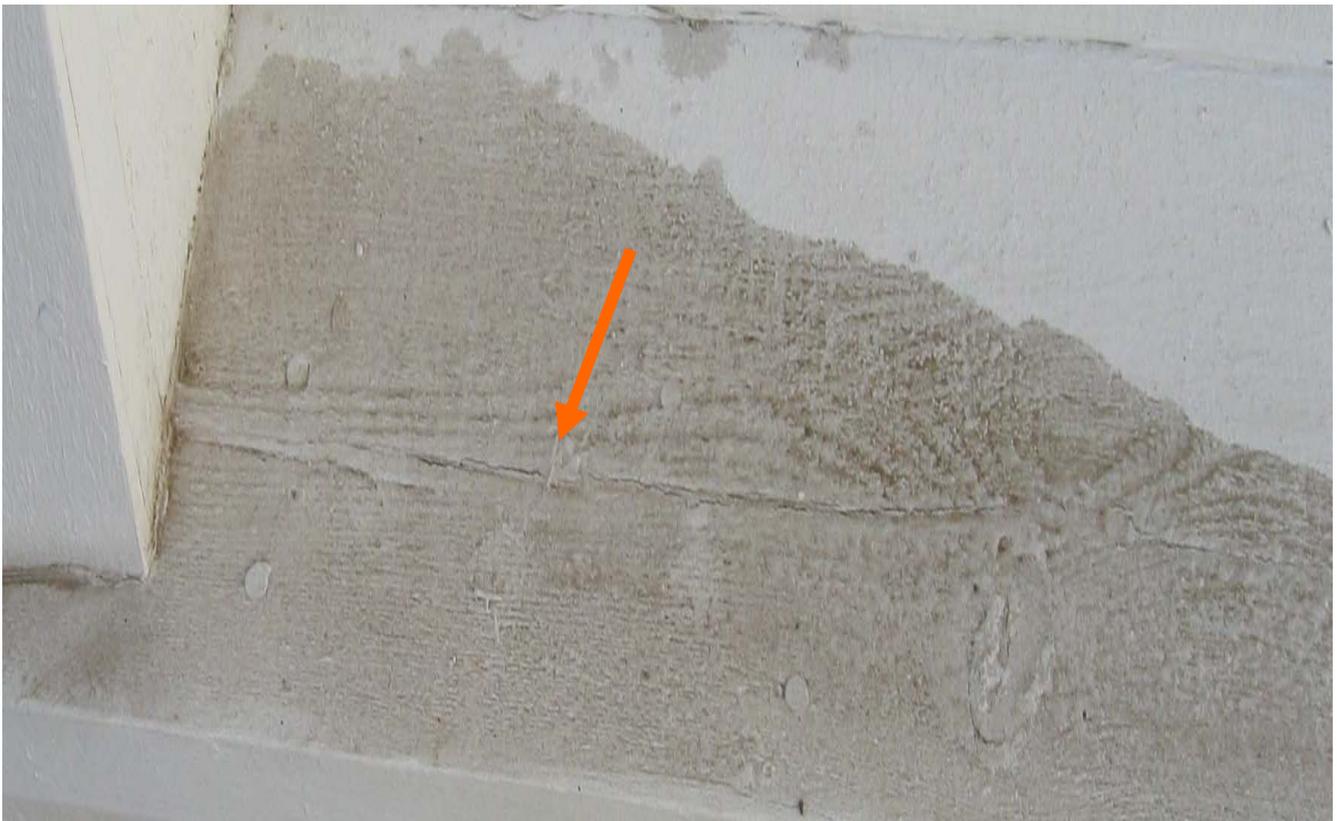
34. The split wood window sills should be replaced. Water leaking through unsealed areas will cause structural damage. The water leakage could also cause fungal growth.

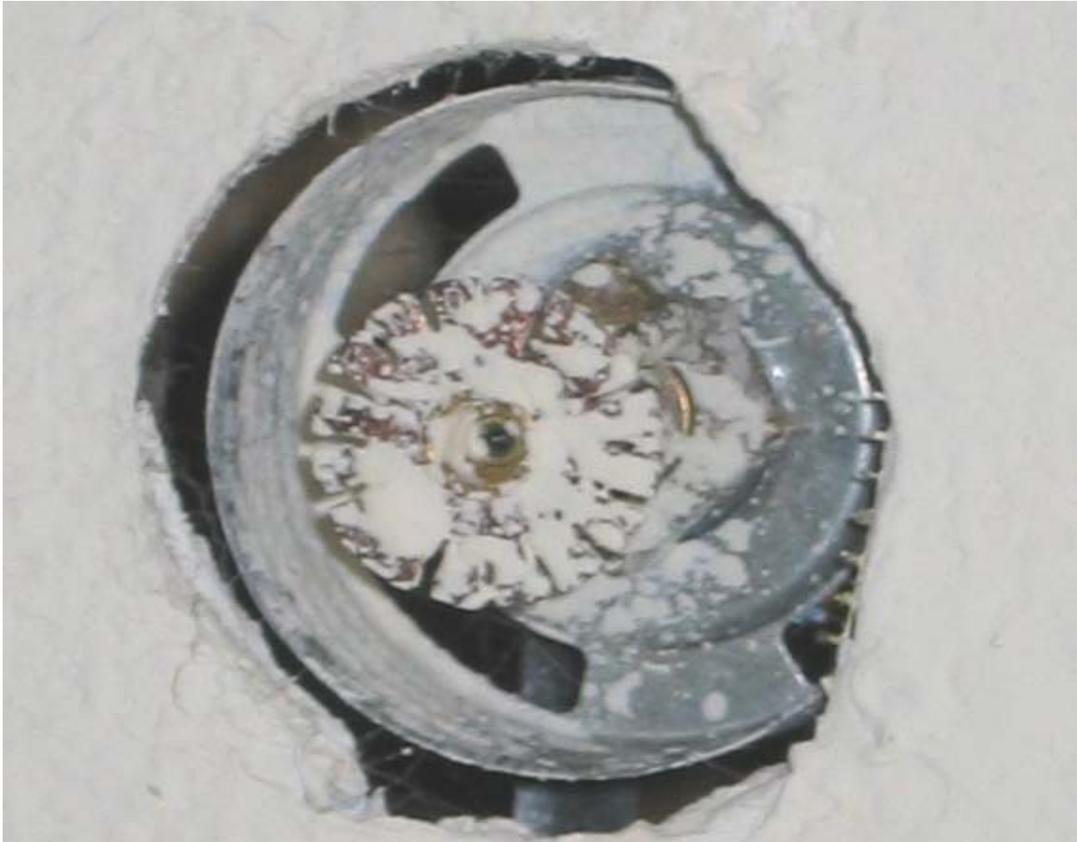
- 39. The missing and loose interior sprinkler head covers should be properly installed.
- 40. The painted sprinkler head at the 1<sup>st</sup> floor hallway should be replaced.

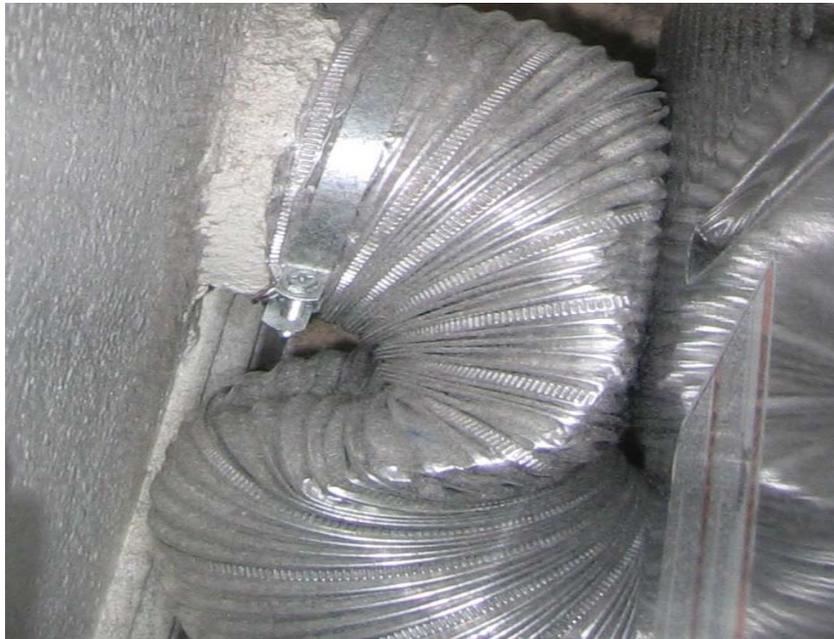
44. The kinked clothes dryer exhaust vent pipe should be replaced. The Consumer Product Safety Commission estimates there are 24,000 clothes dryer fires each year in the United States. It is believed many of these incidents could be eliminated by using more durable and efficient venting systems. Metal venting resists crushing better than vinyl or foil, allowing the air and lint to be carried out of the system. Furthermore, reduced airflow from build-up or crushing can cause overheating and wear out the clothes and the appliance faster. Lint accumulation and reduced exhaust airflow feed on each other to provide conditions ripe for a fire. Lint is highly combustible. Decreased airflow causes overheating of the exhaust environment, demanding excessive cycling of the high temperature limit switch and eventual failure. If clothes are taking a long time to dry or come out hotter than normal, or if the vent hood flapper doesn't open, maintenance is needed. Here are actions available to minimize the potential for dryer fires, even before the warning signs show up: Avoid kinking or crushing the exhaust vent piping to make up for installation in close quarters. This only restricts airflow further. Minimize the length of exhaust duct; it should never exceed 25 feet.
