Property Inspection Report

Sample Residential Inspection, CA 95014

**Report Number:
I0824434**

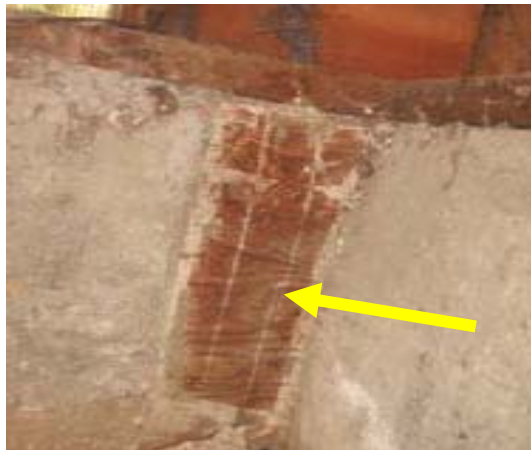
Form Boards

- **Repair:** The remaining foundation wood form boards should be treated or removed

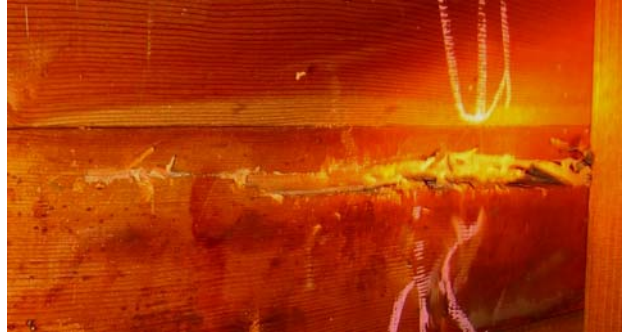
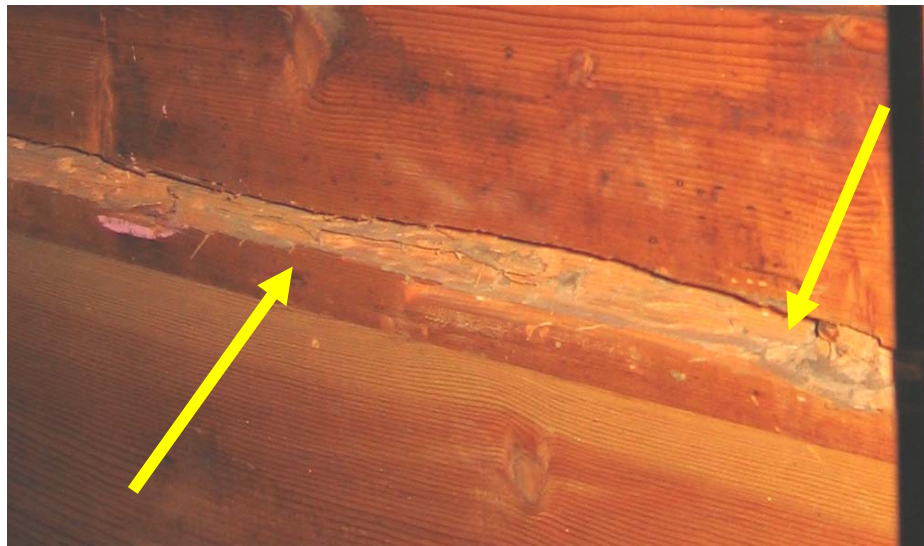
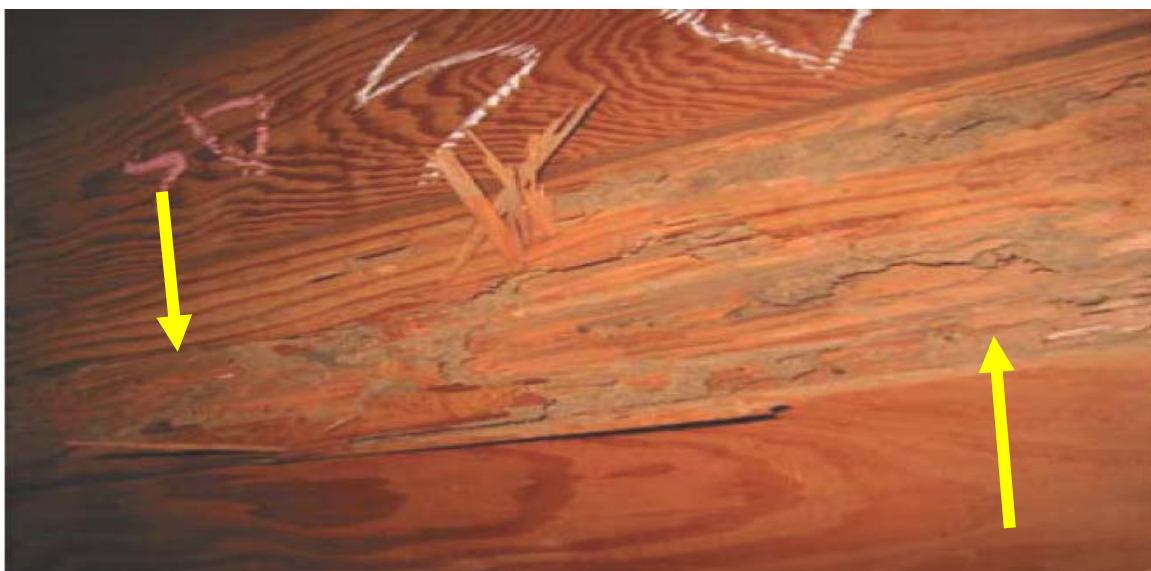
Floors

- **Repair:** The wood framed floor structure squeaks in various locations.
- **Repair:** The wood framing floor structure shows evidence of wood boring insect activity at the kitchen and dining room locations. All damaged wood should be replaced. Recommendation: Review the section one items on the termite inspector's report.

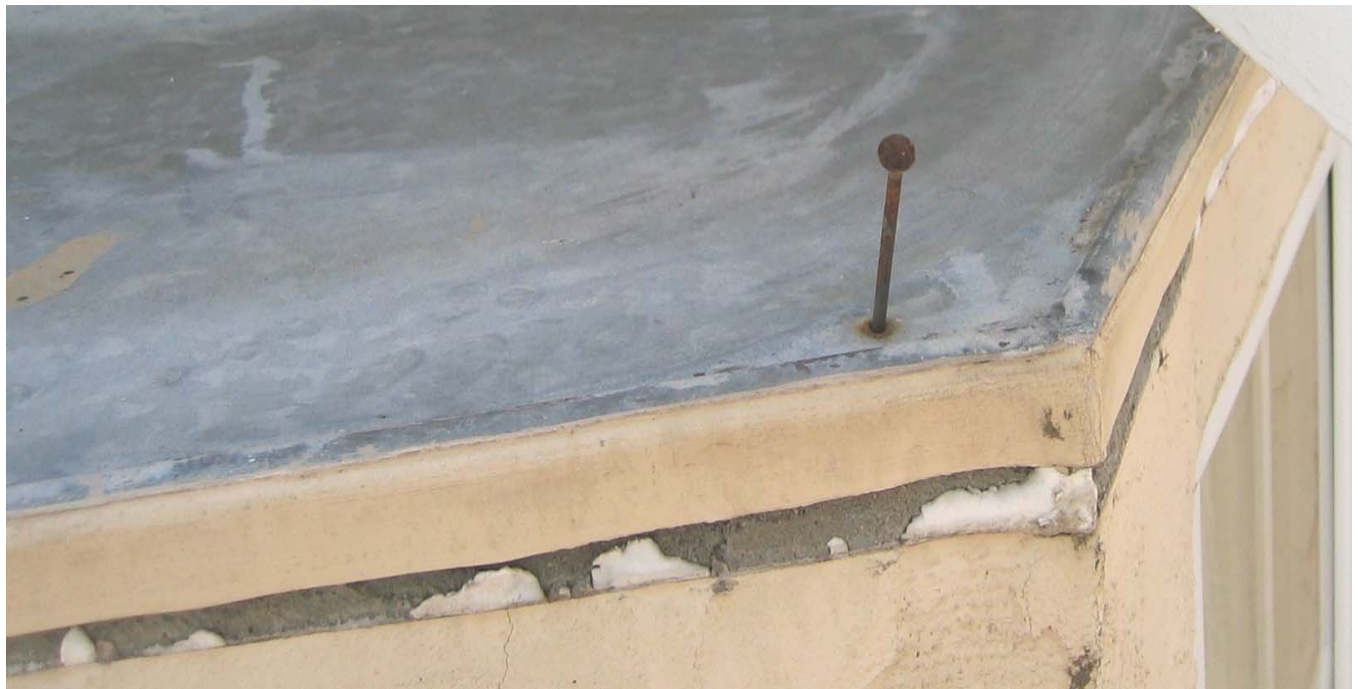
Bay Windows

- **Repair:** The metal roofing at the kitchen bay window is improperly installed. The roof is also secured with steel nails through the top. Recommendation: Replace the metal roofing.

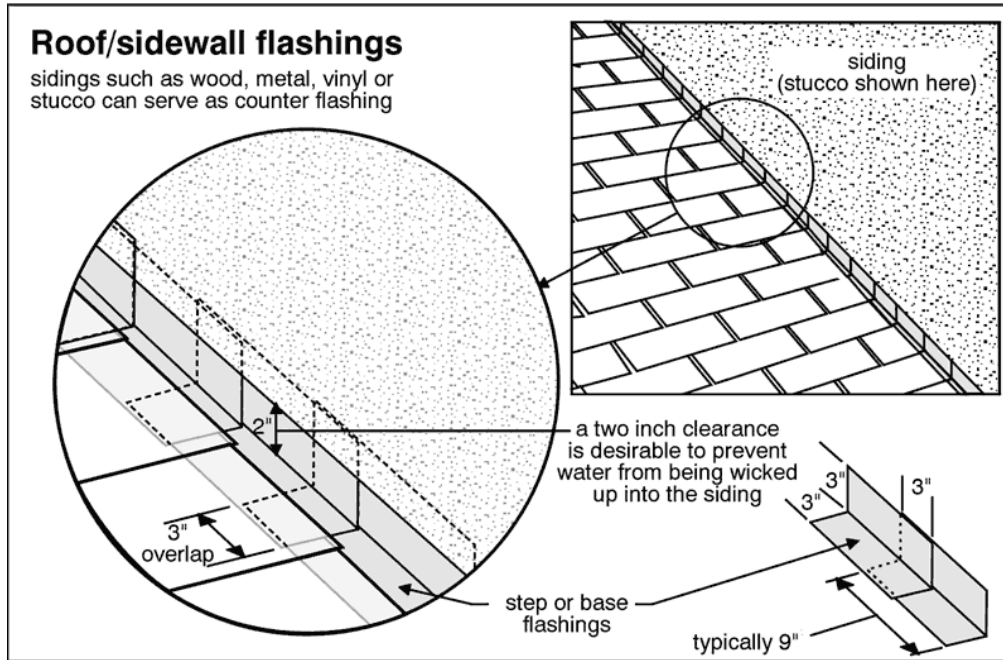
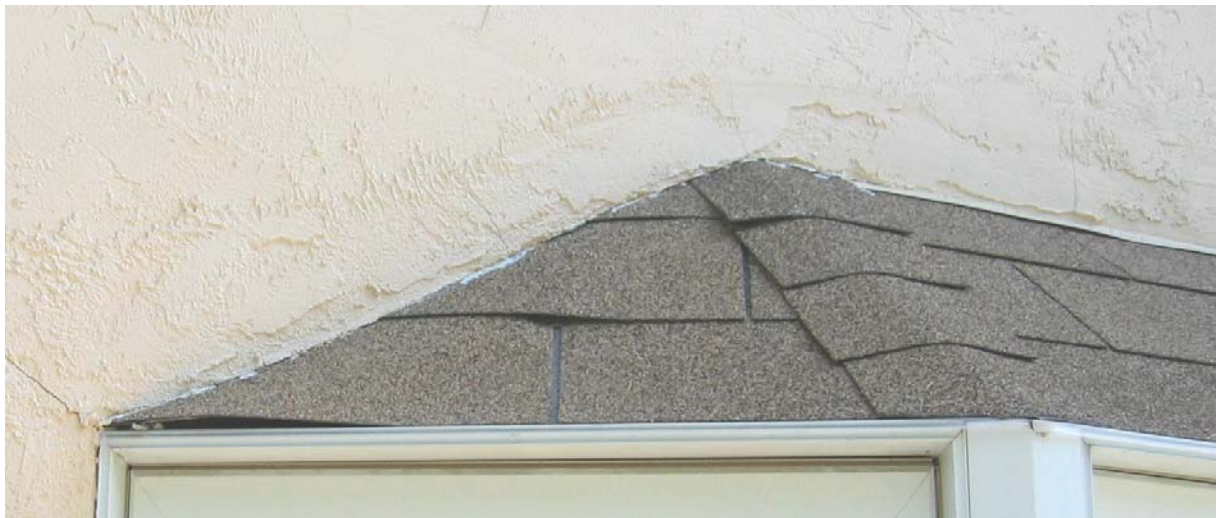
Living Room Bay Window

- **Repair:** The flashings and composition roofing at the living room bay window are improperly installed. The composition roofing does not extend the minimum one-inch past the window edges and the stucco does not have the proper clearance above the roofing material.

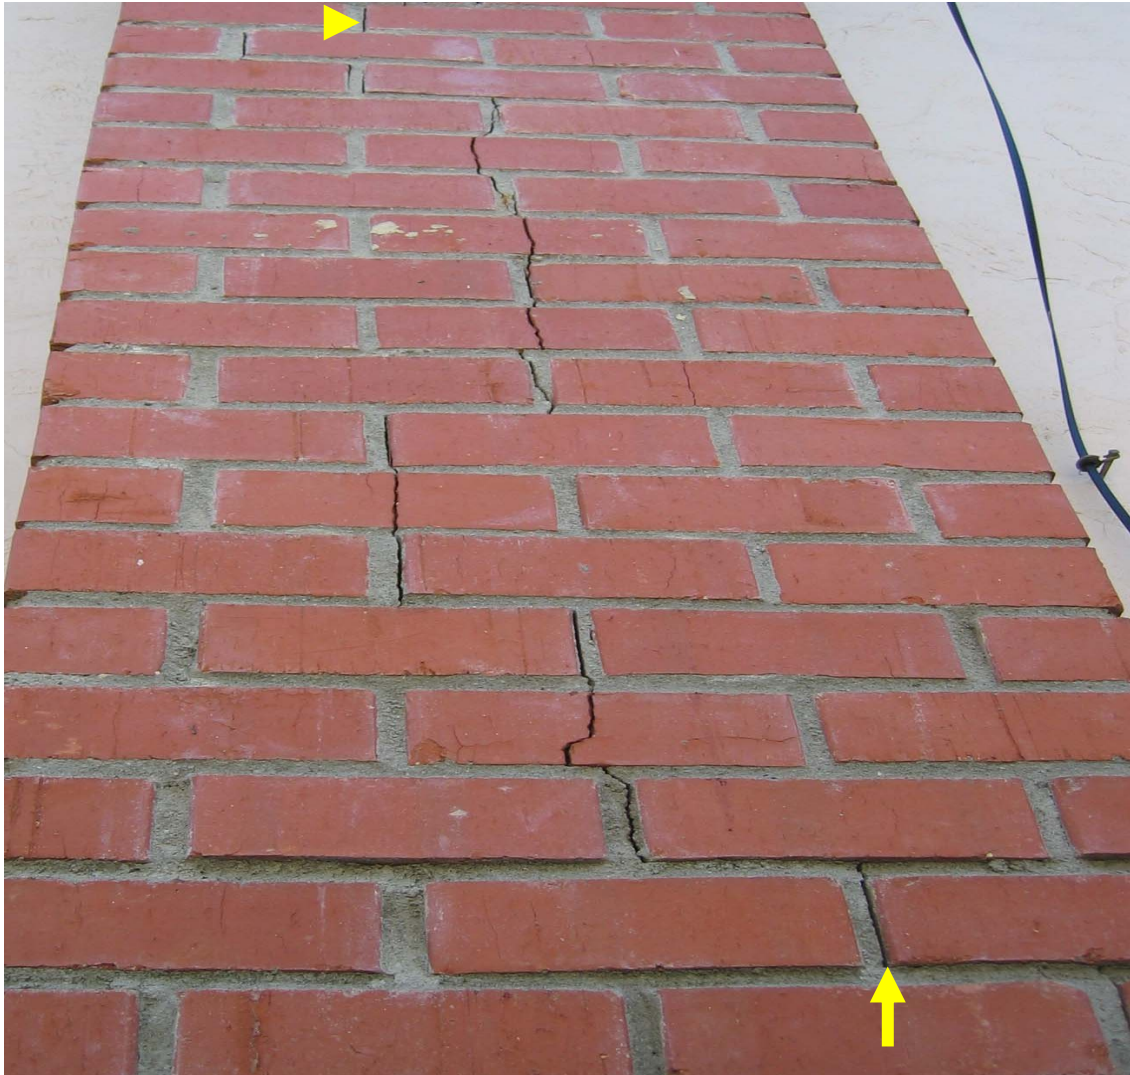
Chimney

- **Major Concern:** The masonry chimney is severely cracked. Repairs will be necessary. A licensed masonry contractor should be consulted for review and corrective work.

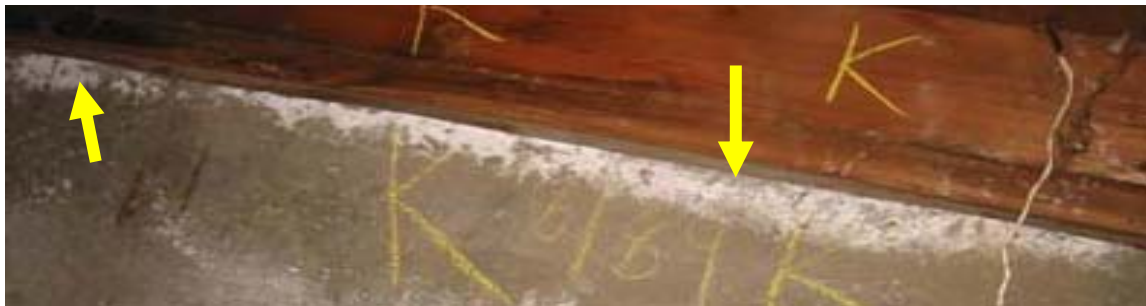
Exterior Doors

- **Repair:** The wood under the threshold at the sliding patio door is damaged. Replacement is recommended.
- **Repair:** The rollers of the sliding glass door could be adjusted to allow the door to operate freely.
- **Repair:** The metal sliding patio door shows evidence of condensation/water intrusion (visible in crawlspace). This type of metal door is notorious for leaking at the threshold. Maintaining a good silicone caulking seal at this vulnerable area is recommended.

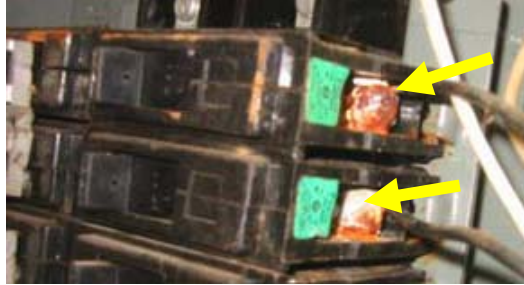
Electrical Panel

- **Repair:** Four of the breakers in the main service panel show evidence of corrosion, suggesting the presence of moisture. This condition is an indication of excessive moisture inside the panel (most leakage?). Corroded breakers are unsafe. Recommendation: A licensed electrician should be consulted to replace the corroded breakers.

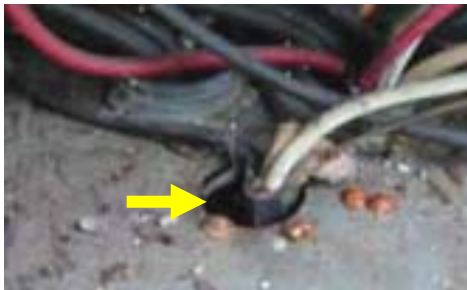
- **Repair:** Cable clamps (sometimes referred to as bushings or grommets) are required where wiring passes into the main distribution panel. Cable clamps serve to protect the wiring from the metal edges of the panel openings.

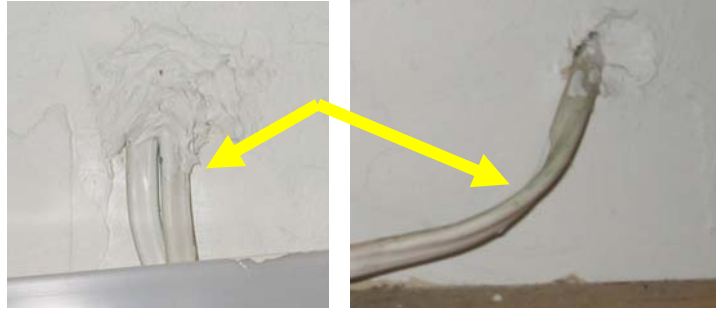
Kitchen

- **Safety Issue:** The kitchen has been remodeled. The remodeling should have included the installation of GFCI outlets at all outlets above the countertop and at all locations within six feet of a water source. Recommendation: Install a GFCI outlet at the right wall outlet near the sink.
- **Repair:** The kitchen wiring exposed on interior finishes should be relocated or protected by a rigid conduit.

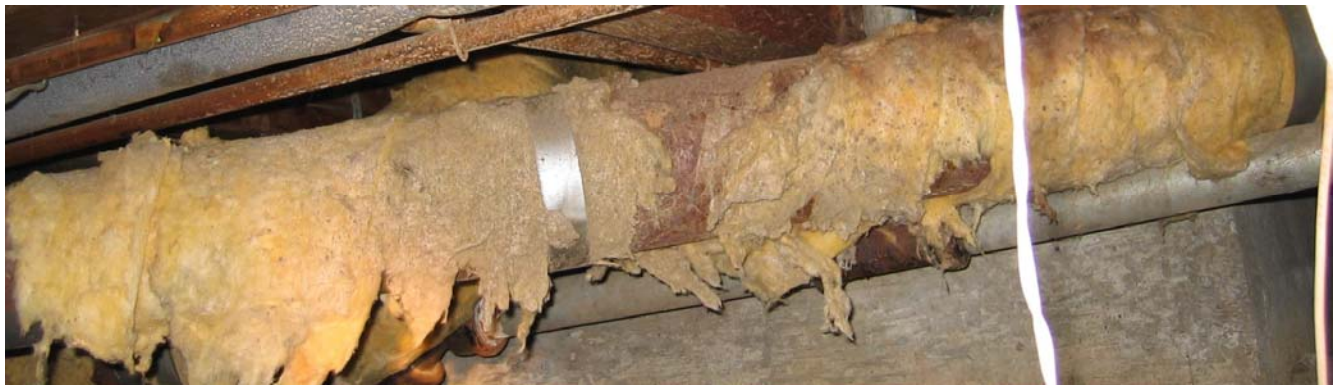
Ductwork

- **Repair:** Damaged/loose joints of the ductwork in the crawlspace should be repaired. The damaged and/or loose joints in the ductwork system will cause a lack of efficiency and conditioned air loss. Recommendation: Pressure testing the ductwork system can help identify where the leakage is occurring and focus repair work in the right areas. A link to more information is available at: http://allbay.net/pdf/duct_testing.pdf.
- **Repair:** Damaged/missing ductwork insulation in the crawlspace should be replaced.

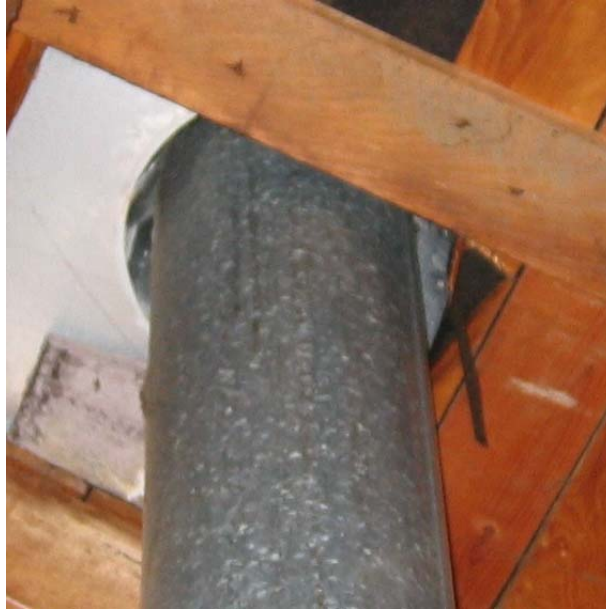
Furnace Exhaust Flue

- **Safety Issue:** The “B-Vent” metal flue piping from the furnace is not sufficiently clear from combustible materials (roof sheeting and roof felt paper). A one-inch clearance from any combustible material is required. The clearance should be improved (fire safety).

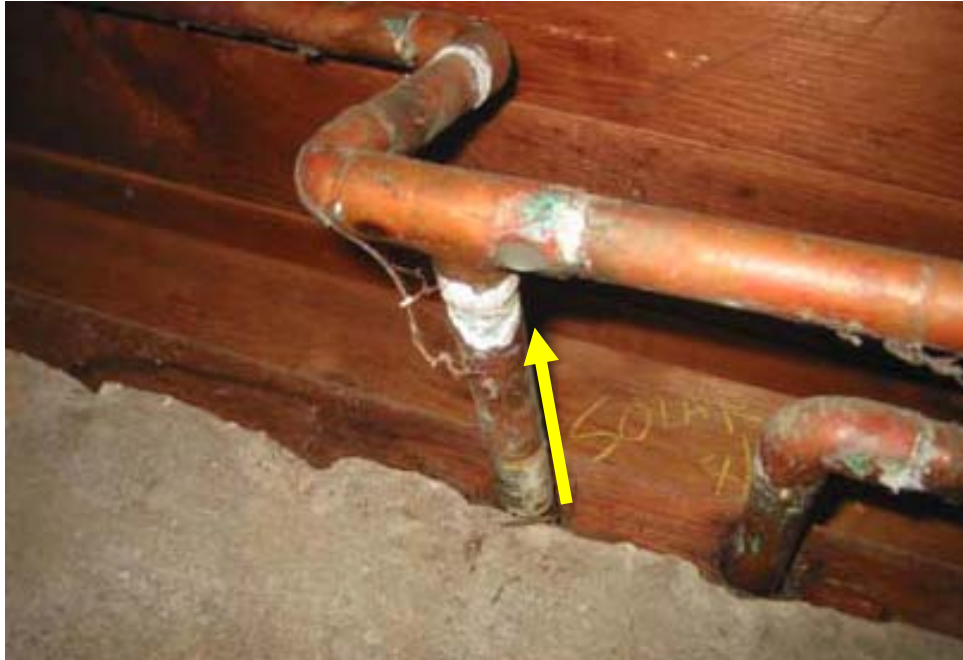
- **Repair:** The water piping is leaking under the powder room.
