Property Inspection Report

Sample Home Inspection Report , CA 95014

Report Number:
I0903450

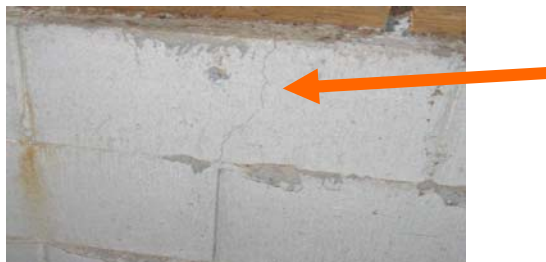
Foundation Cracks

- **Monitor:** Common minor hairline cracks were observed in the foundation walls of the home. No displacement was noted. This type of cracking implies that some minor structural movement of the home has occurred, as is typical of most homes.

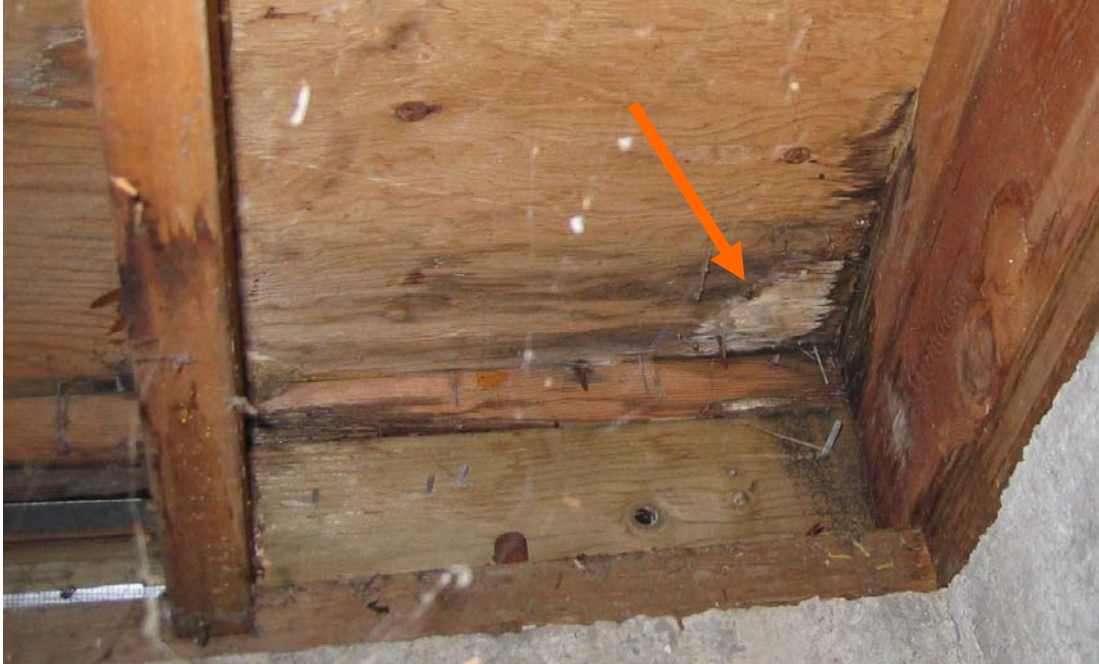
Floors

- **Repair:** The wood framing floor structure shows evidence of rot at the master bathroom location. Rot weakens the structure and causes distress to the building. All damaged wood should be replaced. Recommendation: Review the section one items on the termite inspector's report.

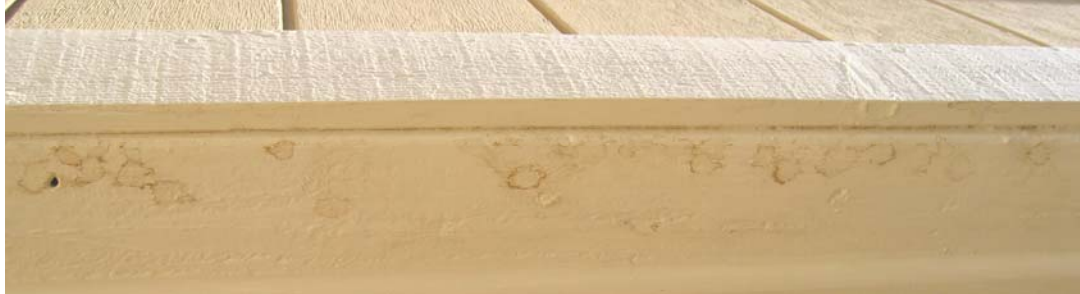
Overhead Garage Door Trim

- **Repair:** The bottoms of the overhead wood garage door and the garage service door jambs are in contact with the asphalt driveway. This type of installation is prone to rot and/or insect activity. Recommendation: Replace the damaged trim.
- **Repair:** The top trim at the garage door shows evidence of water intrusion.

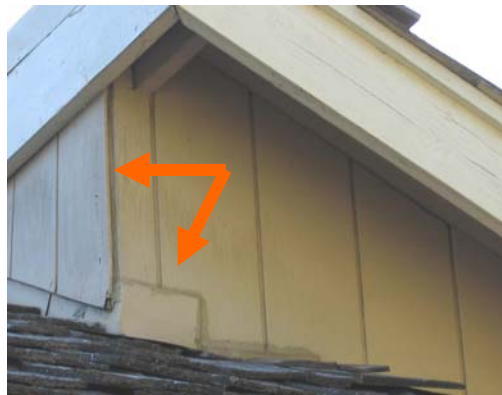
- **Repair:** The loose siding at the front entry wall, family room chimney and above the kitchen sink window should be repaired.
- **Repair:** The missing outside corner trim at the kitchen should be replaced. The roof to wall flashings are also incorrectly installed at this location. The flashings should be under the siding.

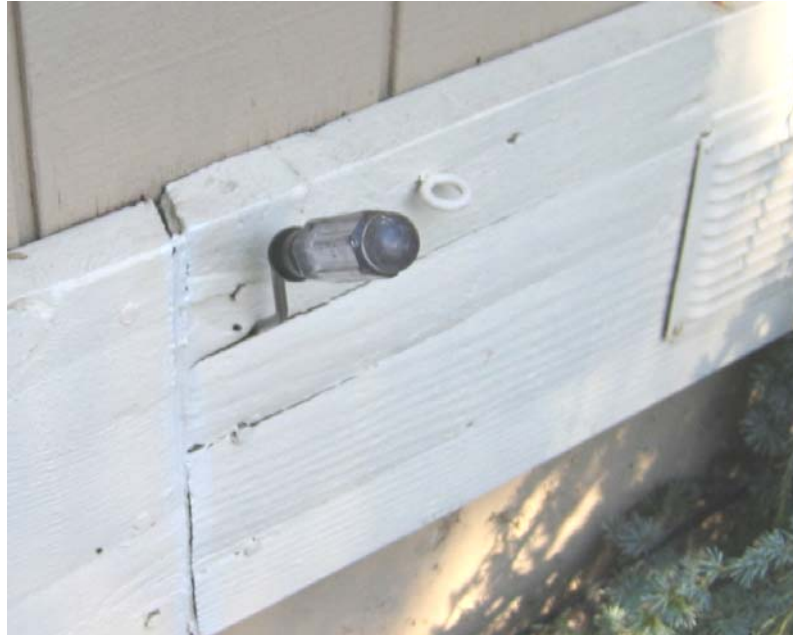
- **Repair:** To help preserve the structure the wood exterior components should be painted.
- **Repair:** Water staining was observed on the eaves at the master bathroom and kitchen roof windows of the home. The roof is leaking in these areas.
- **Repair:** The rotted wood trim at the master bathroom roof window location should be repaired or replaced.
- **Repair:** The rotted band boards at the front wall and above the garage should be replaced.

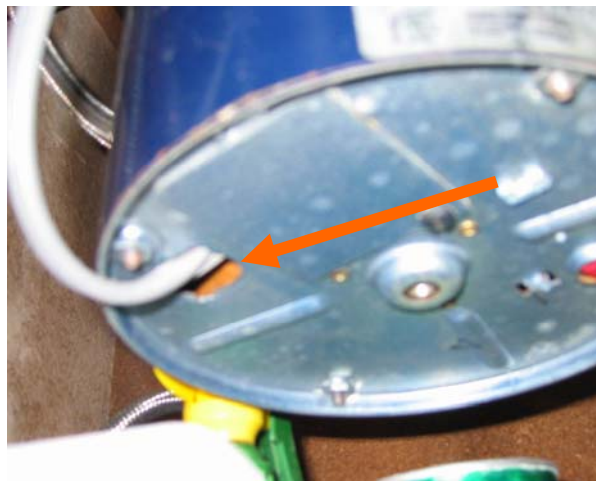
Kitchen

- **Repair:** The wiring at the kitchen waste disposal is incomplete. The cable clamp is missing at the disposal location. Installation is recommended.

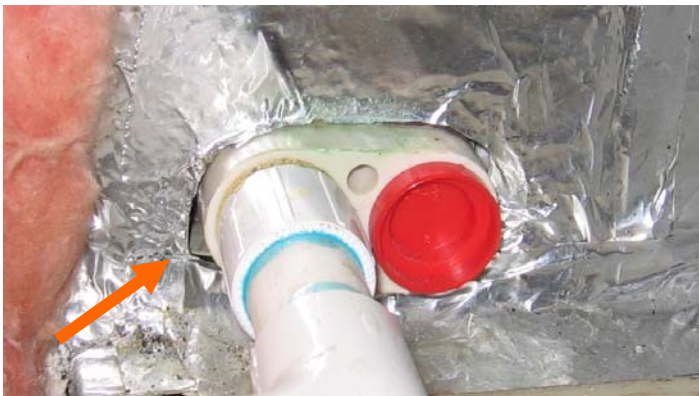
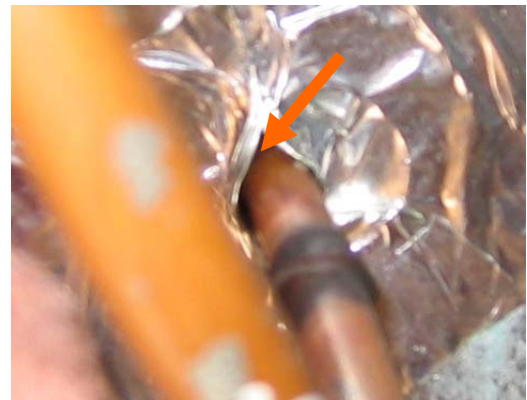
Plenum Leakage

- **Repair:** The air leaks at the furnace should be improved. Conditioned air was leaking from the furnace at several locations of the plenum.

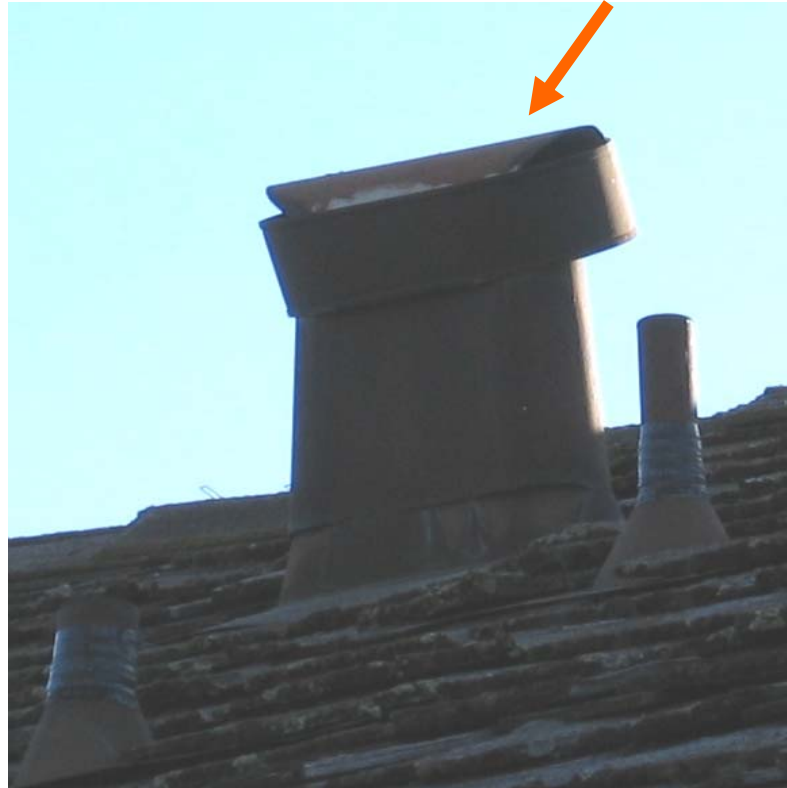
Furnace Exhaust Flue

- **Safety Issue:** The rooftop furnace flue cap has collapsed. This could block the proper flow of combustion gasses. Recommendation: Replace the vent cap.

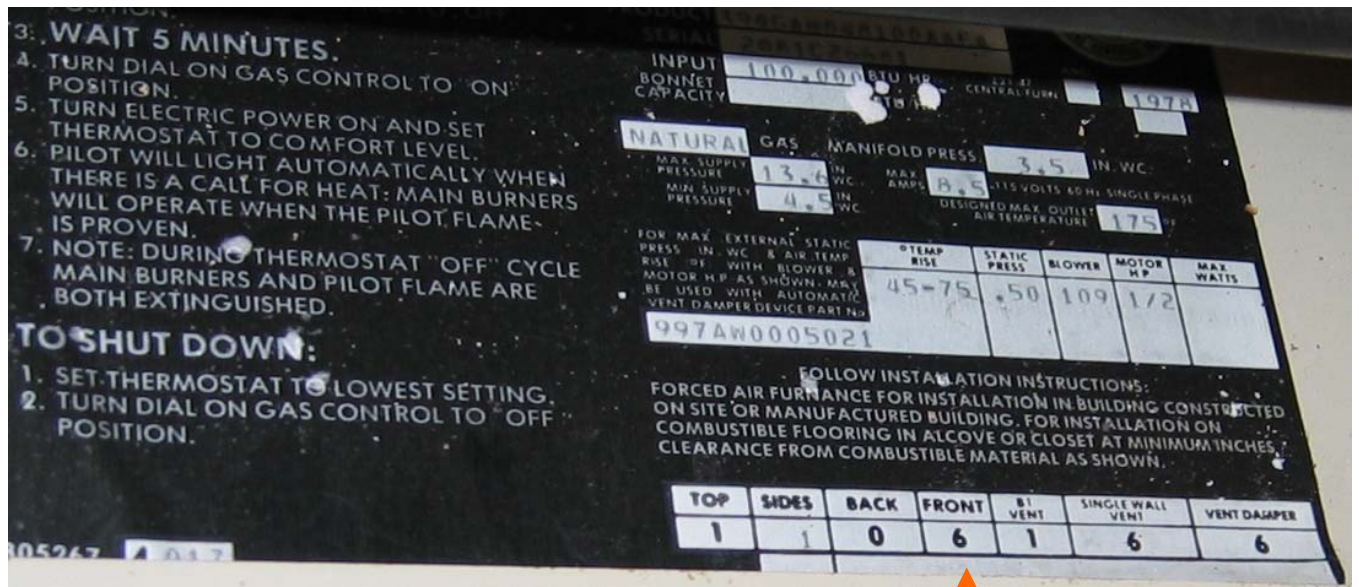
Furnace Clearance

- **Safety Issue:** The clearance of the forced-air furnace from combustibles is unsafe. The furnace manufacturer requires a minimum of a six inch clearance from combustible material at the front of the furnace. This situation can pose a safety threat and a fire hazard.

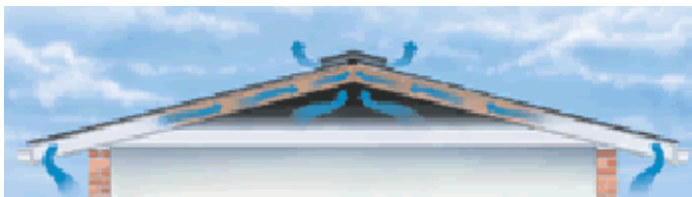
Attic Ventilation

- **Repair:** The level of ventilation throughout the attic should be improved. It is generally required that one square foot of free vent area be provided for every one hundred and fifty square feet of ceiling area. Proper ventilation will help to keep the home and garage cooler during warm weather and extend the life of the roofing materials. Proper ventilation will also help reduce the potential for heat build-up and condensation within the attic.

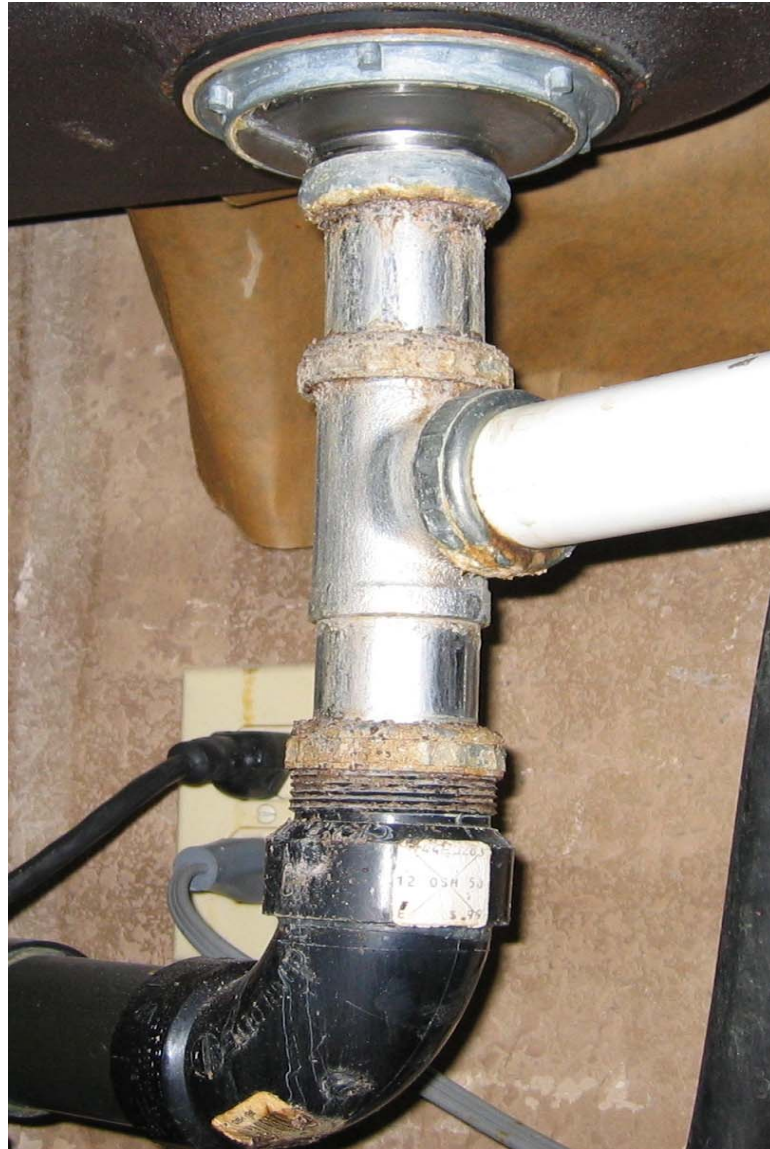
Waste Piping

- **Repair:** The commode is loose in the master bathroom.
- **Repair:** The waste connection is leaking in the kitchen.

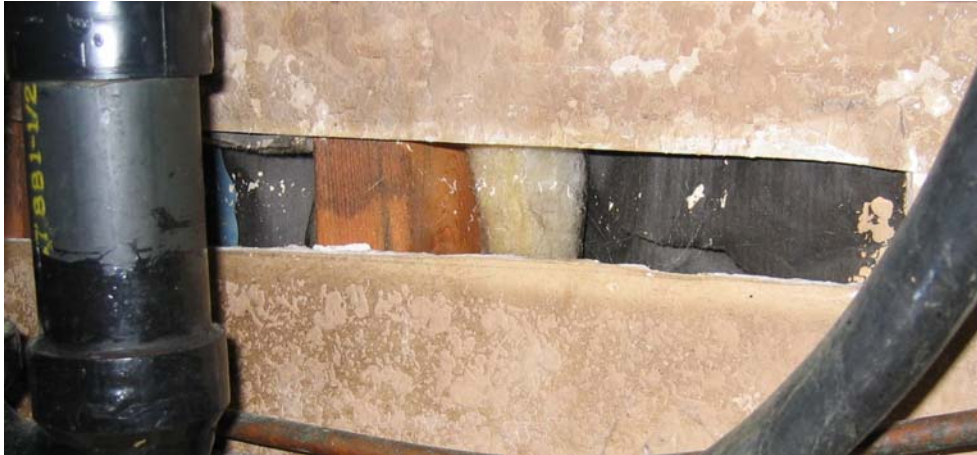
Kitchen

- **Repair:** The open wall at the kitchen sink base location should be sealed/re-sheetrocked.
