# All Bay Home Inspection, Inc.

**Inspection Address:** Gilroy, Ca 95020

**Subject:** Property Inspection, New Construction

Upon inspection of the new home on November 19, 2004 the following defects were noted:

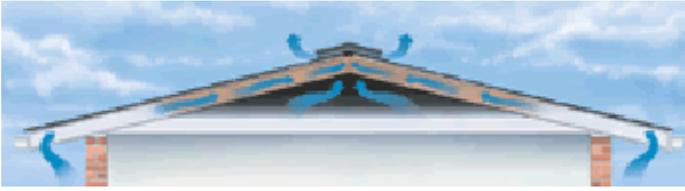
46. The level of ventilation throughout the attic and all roof cavities should be improved. It is generally required that one square foot of free vent area be provided for every one hundred and fifty square feet of ceiling area. Proper ventilation will help to keep the home cooler during

warm weather and extend the life of the roofing materials. Proper ventilation will also help reduce the potential for heat build-up and condensation within the attic.

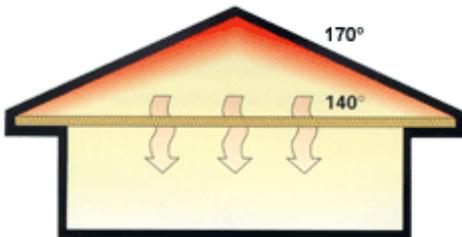
One of the critical aspects of a roof system's durability is the ventilation of the attic or space below the roof. Attic ventilation means exchanging the existing air in an attic for fresh air and allowing the fresh air to circulate throughout the attic. The two basic benefits of

this air exchange are a cooler attic in the summer and a dryer attic in the winter.

These combined benefits provide greater occupant comfort; savings in the energy used for cooling, and help in maintaining the structural integrity of the roof system. Without adequate venting of the under roof or attic area, heat and moisture can build up and possibly lead to premature roof aging and/or structural concerns. Two natural forces help provide ventilation, convection and wind. Convection is the natural tendency for warm air to rise. As the warm air rises in an attic, cooler air is pulled in to replace it. Wind flow over a roof system also creates air movement in the attic as areas of positive and negative pressure are created. The positive wind pressure on the upwind side of a home forces in fresh air, while negative pressures on the downwind side draw out warm moist air. However, for any movement of air to take place, there must be adequate intake and outlet vents. For the airflow to be effective, the vents must be sized properly and positioned at the correct locations in the roof.
