Property Inspection Report

Sample Residential Inspection, CA 95014

**Report Number:
I0824434**

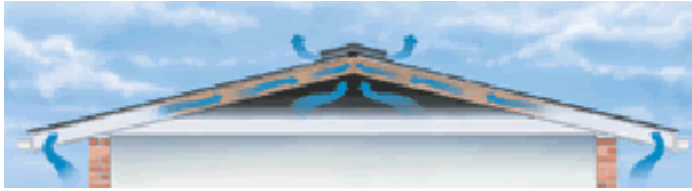
- **Repair:** The level of ventilation throughout the attic should be improved. It is generally required that one square foot of free vent area be provided for every one hundred and fifty square feet of ceiling area. Proper ventilation will help to keep the home and garage cooler during warm weather

and extend the life of the roofing materials. Proper ventilation will also help reduce the potential for heat build-up and condensation within the attic.
